**PROPERTY CONDITION ASSESSMENT
OF
WORLD TRADE CENTER PORTFOLIO**

TWO WORLD TRADE CENTER

**Re: Due Diligence Physical Condition Survey
World Trade Center
New York, New York**

**REPORT OF
DUE DILIGENCE PHYSICAL CONDITION SURVEY
WORLD TRADE CENTER**

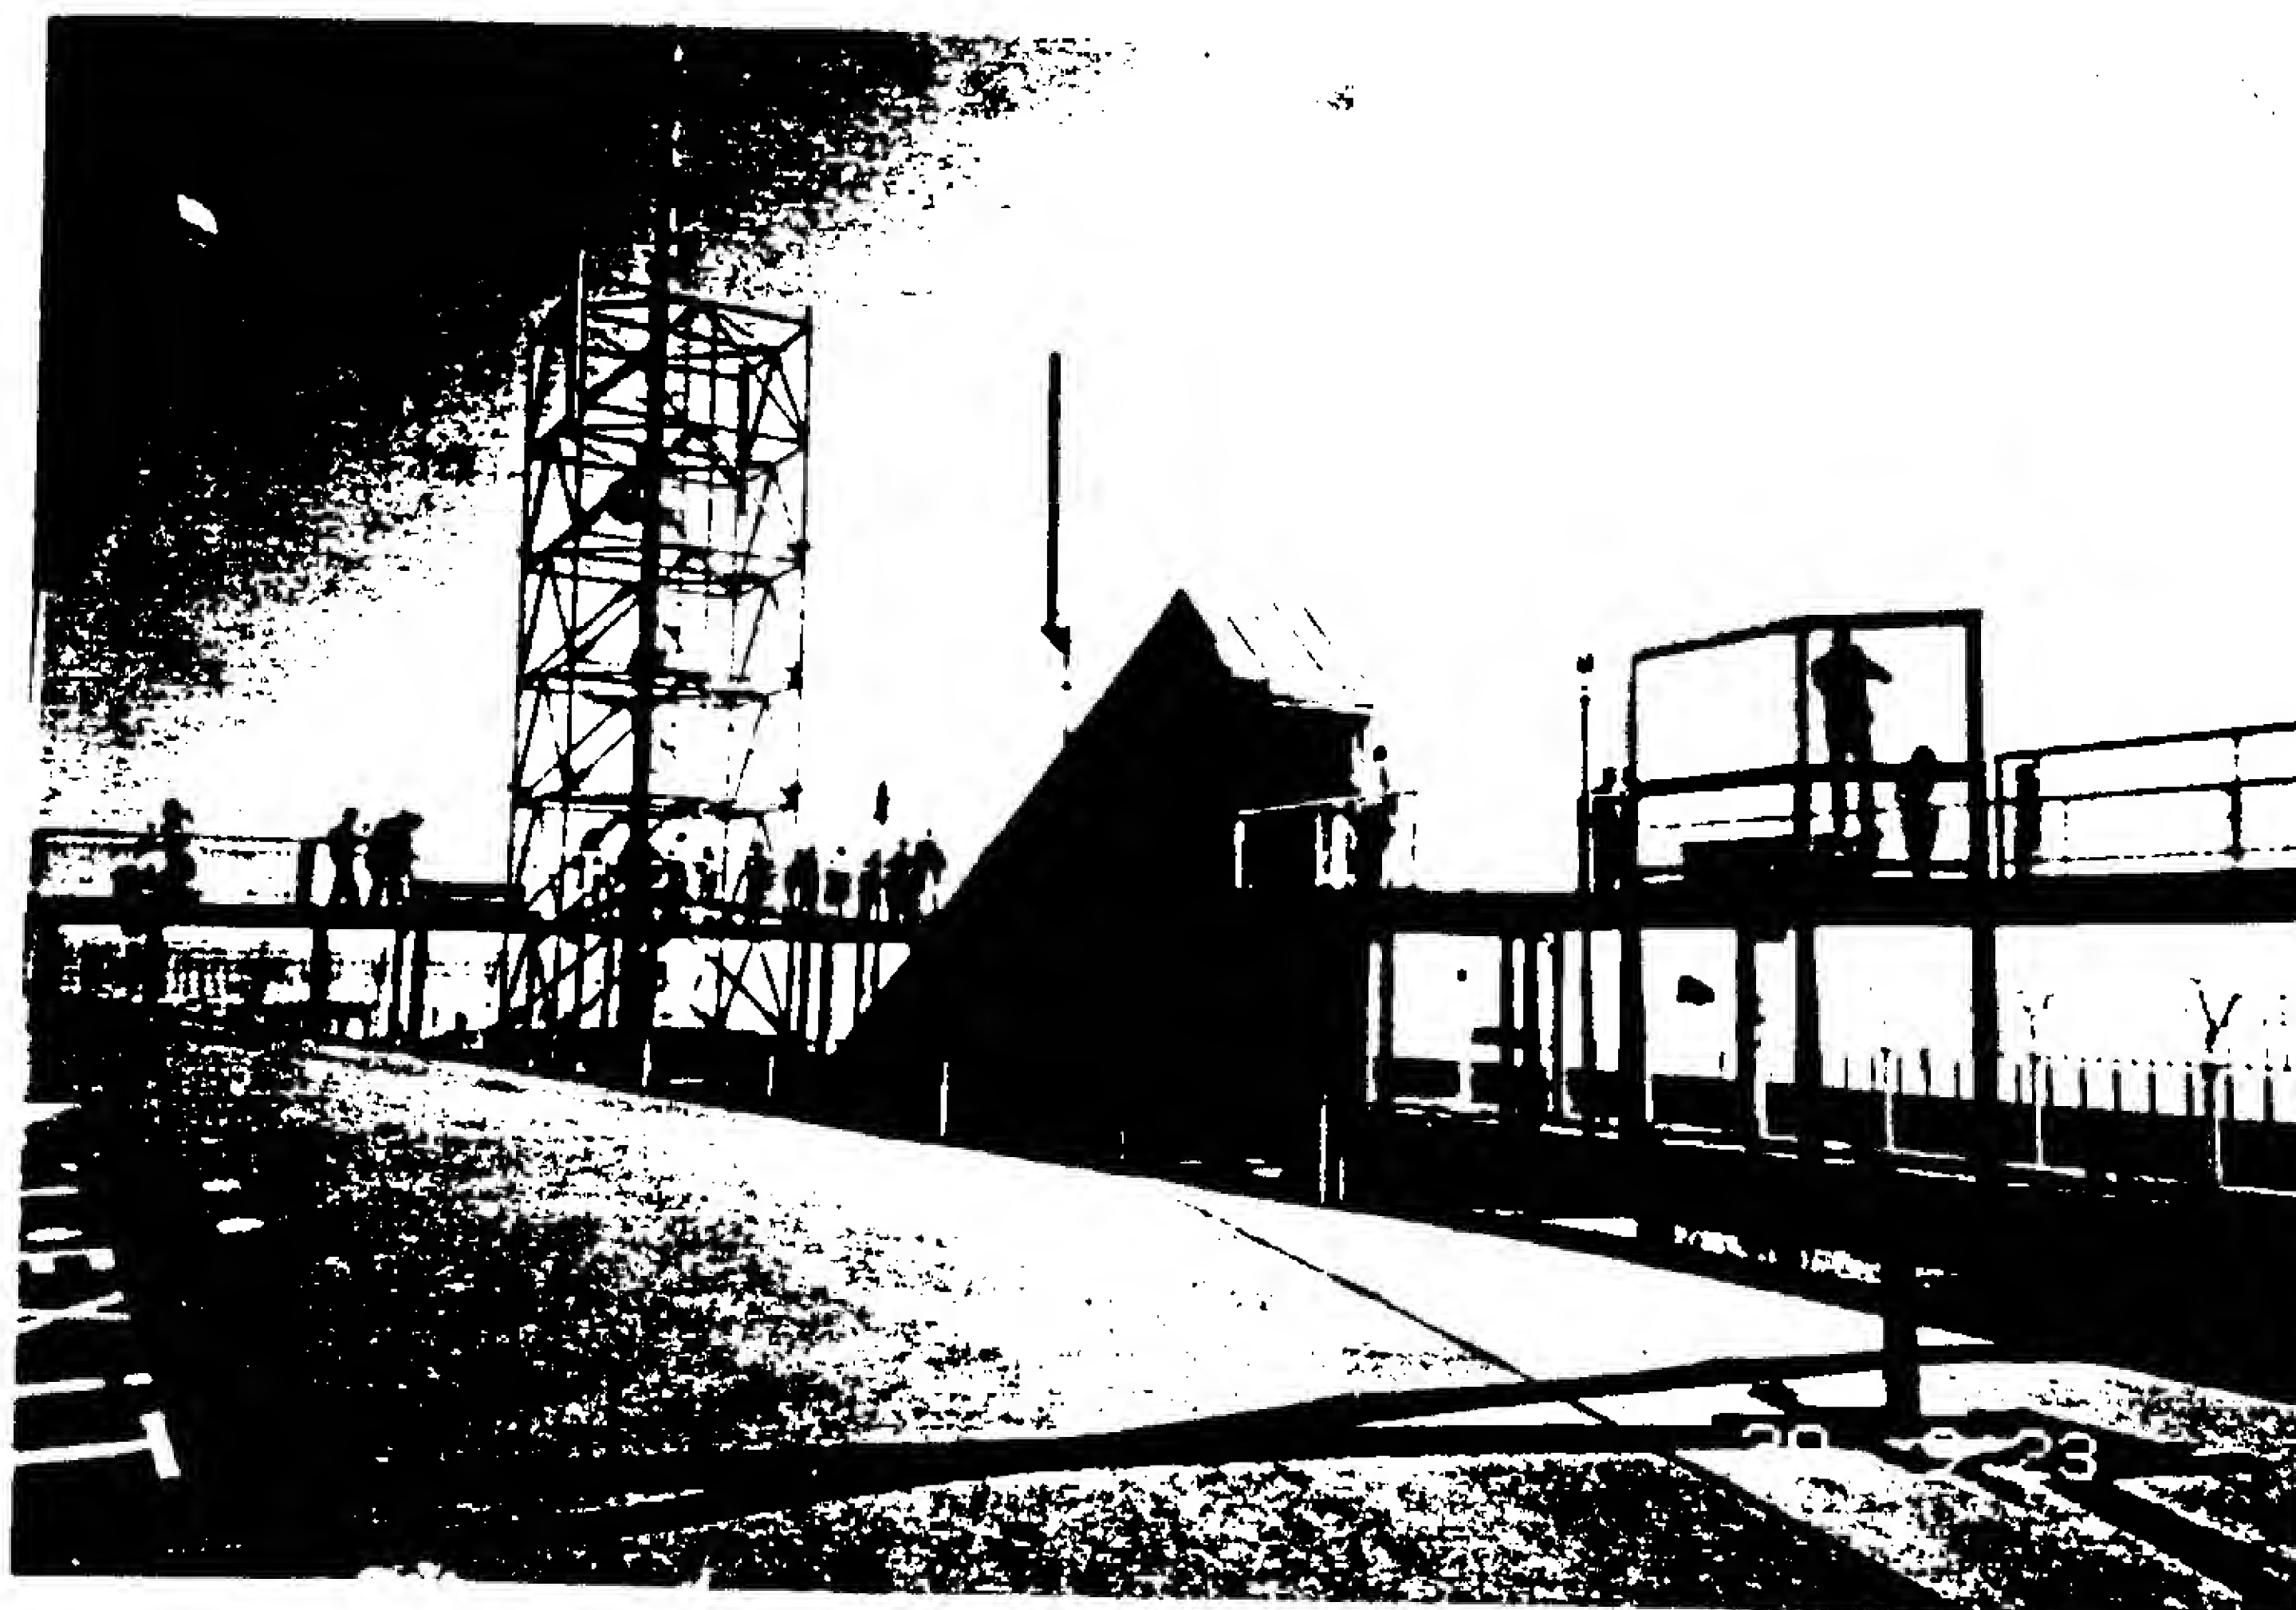
Photograph 5

Entrance to rooftop
observation deck;
note concrete
covered roof

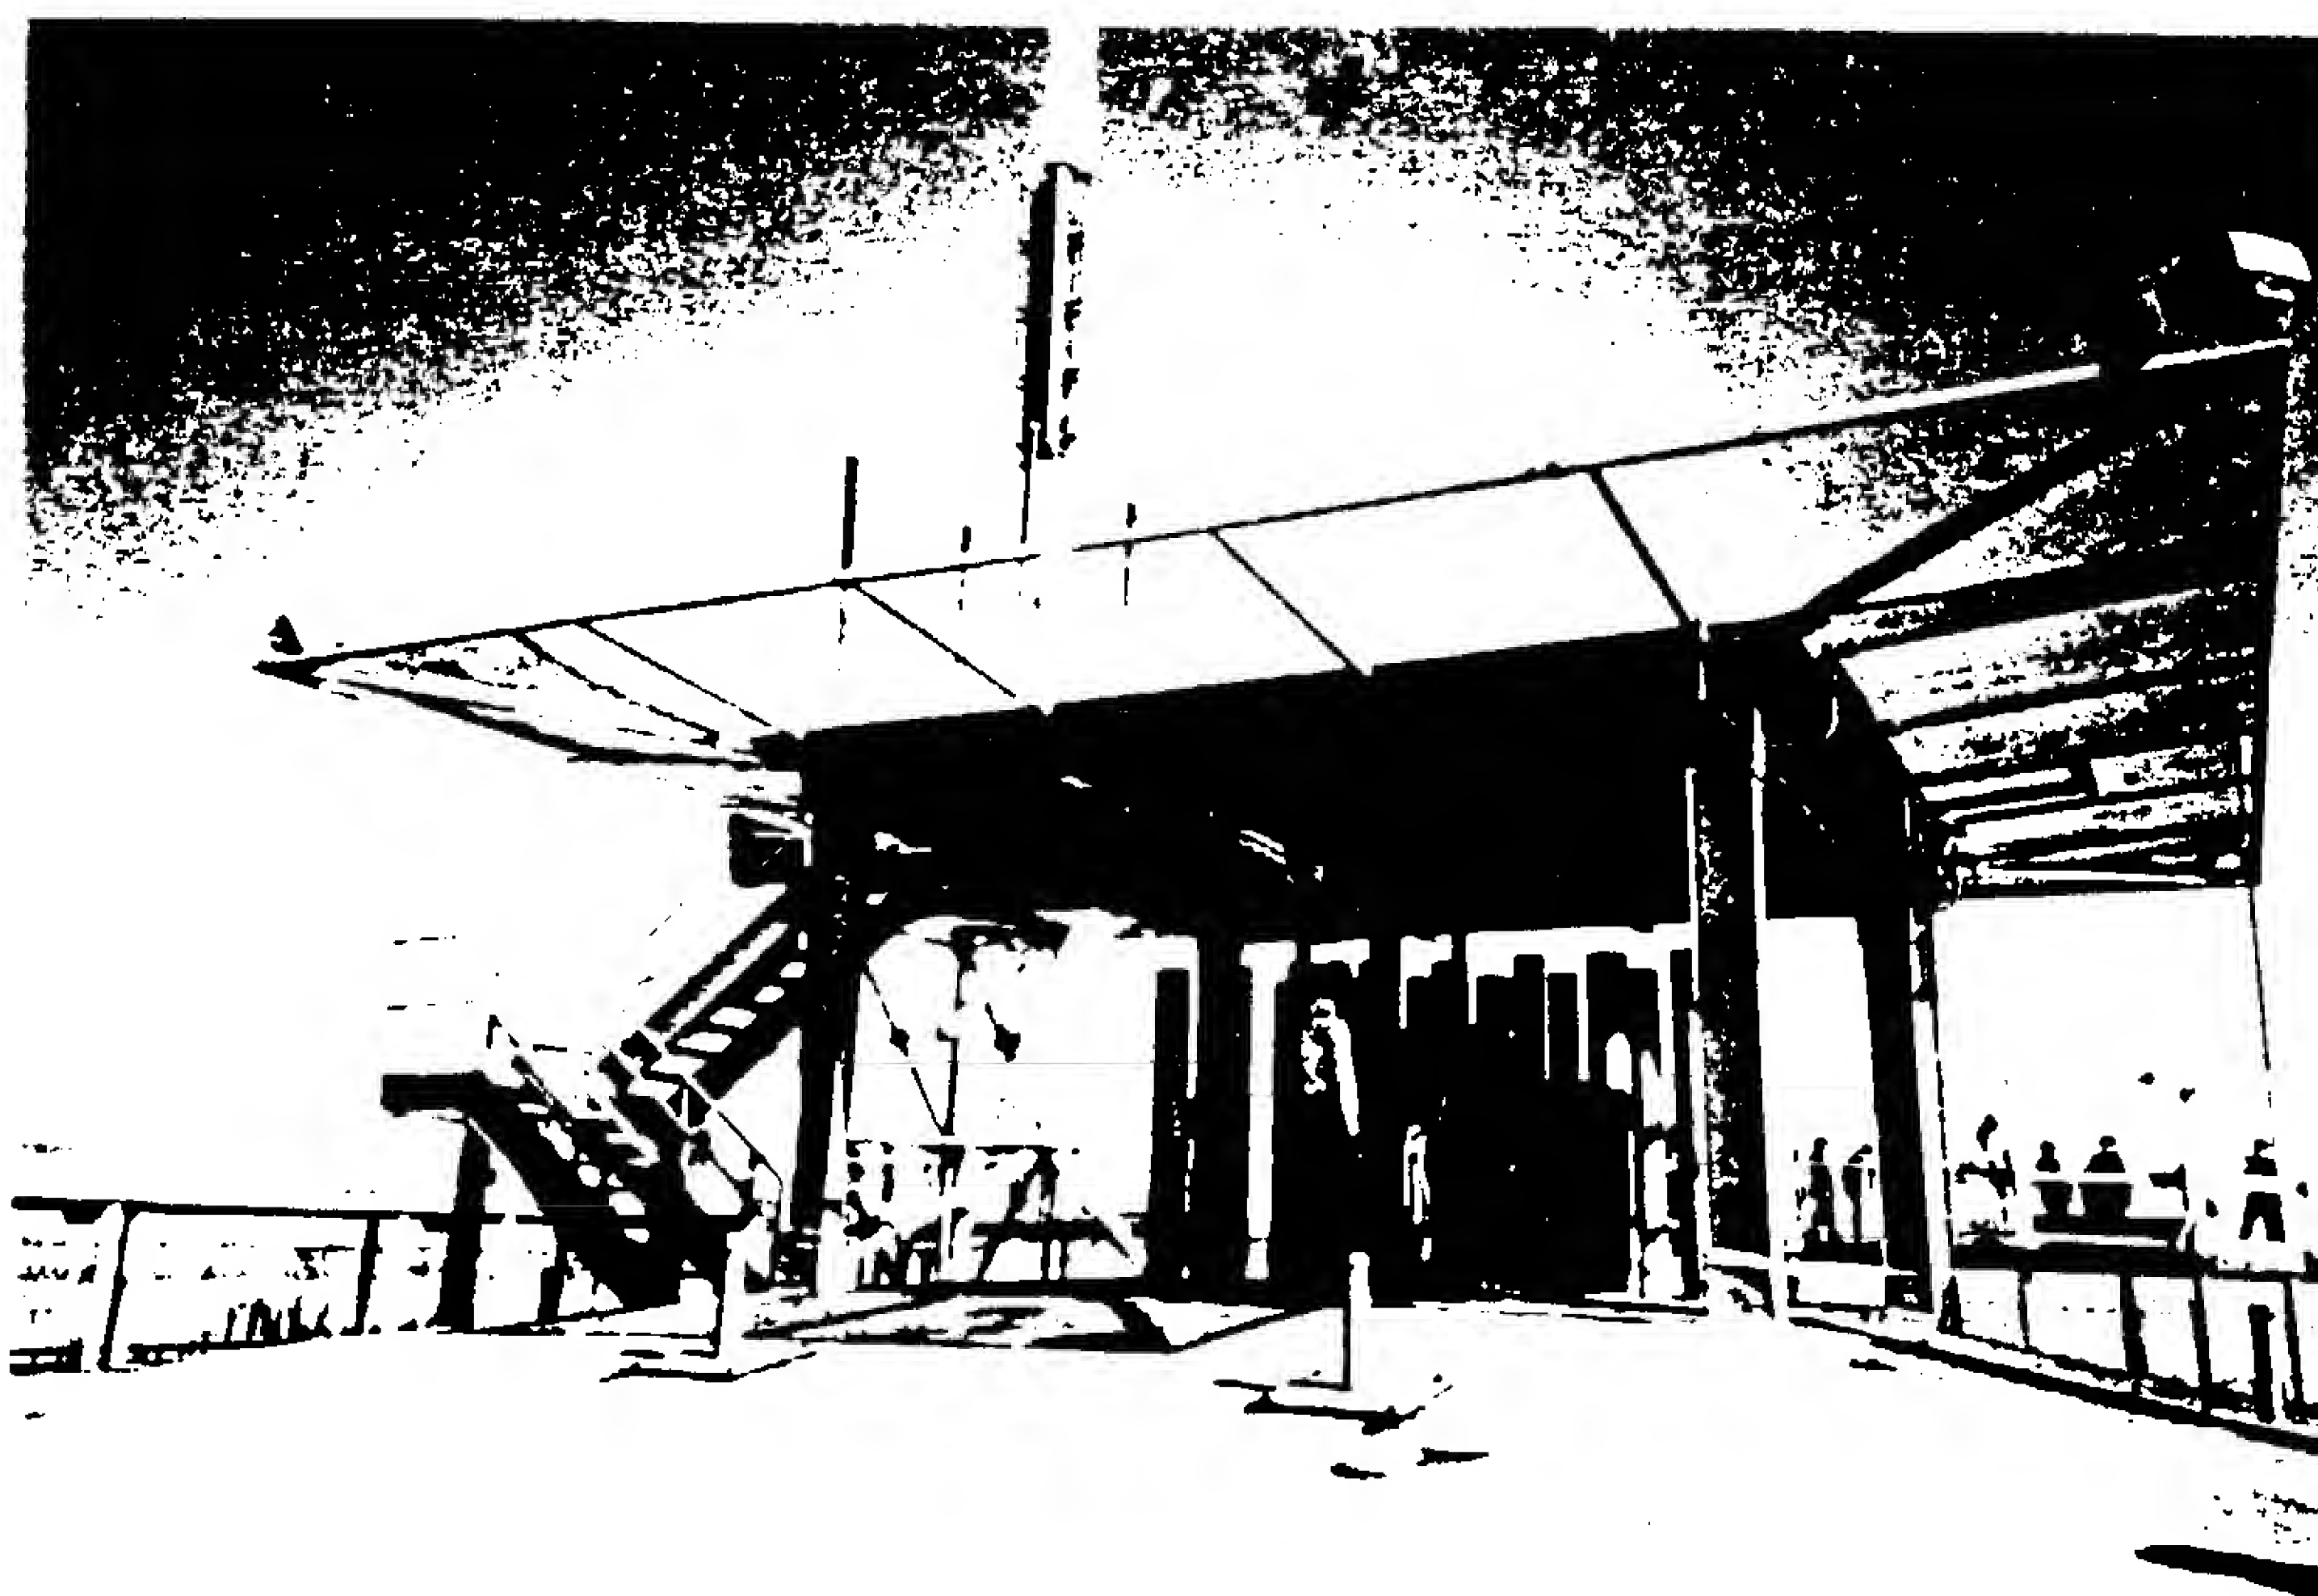
Photograph 6

Helicopter pad

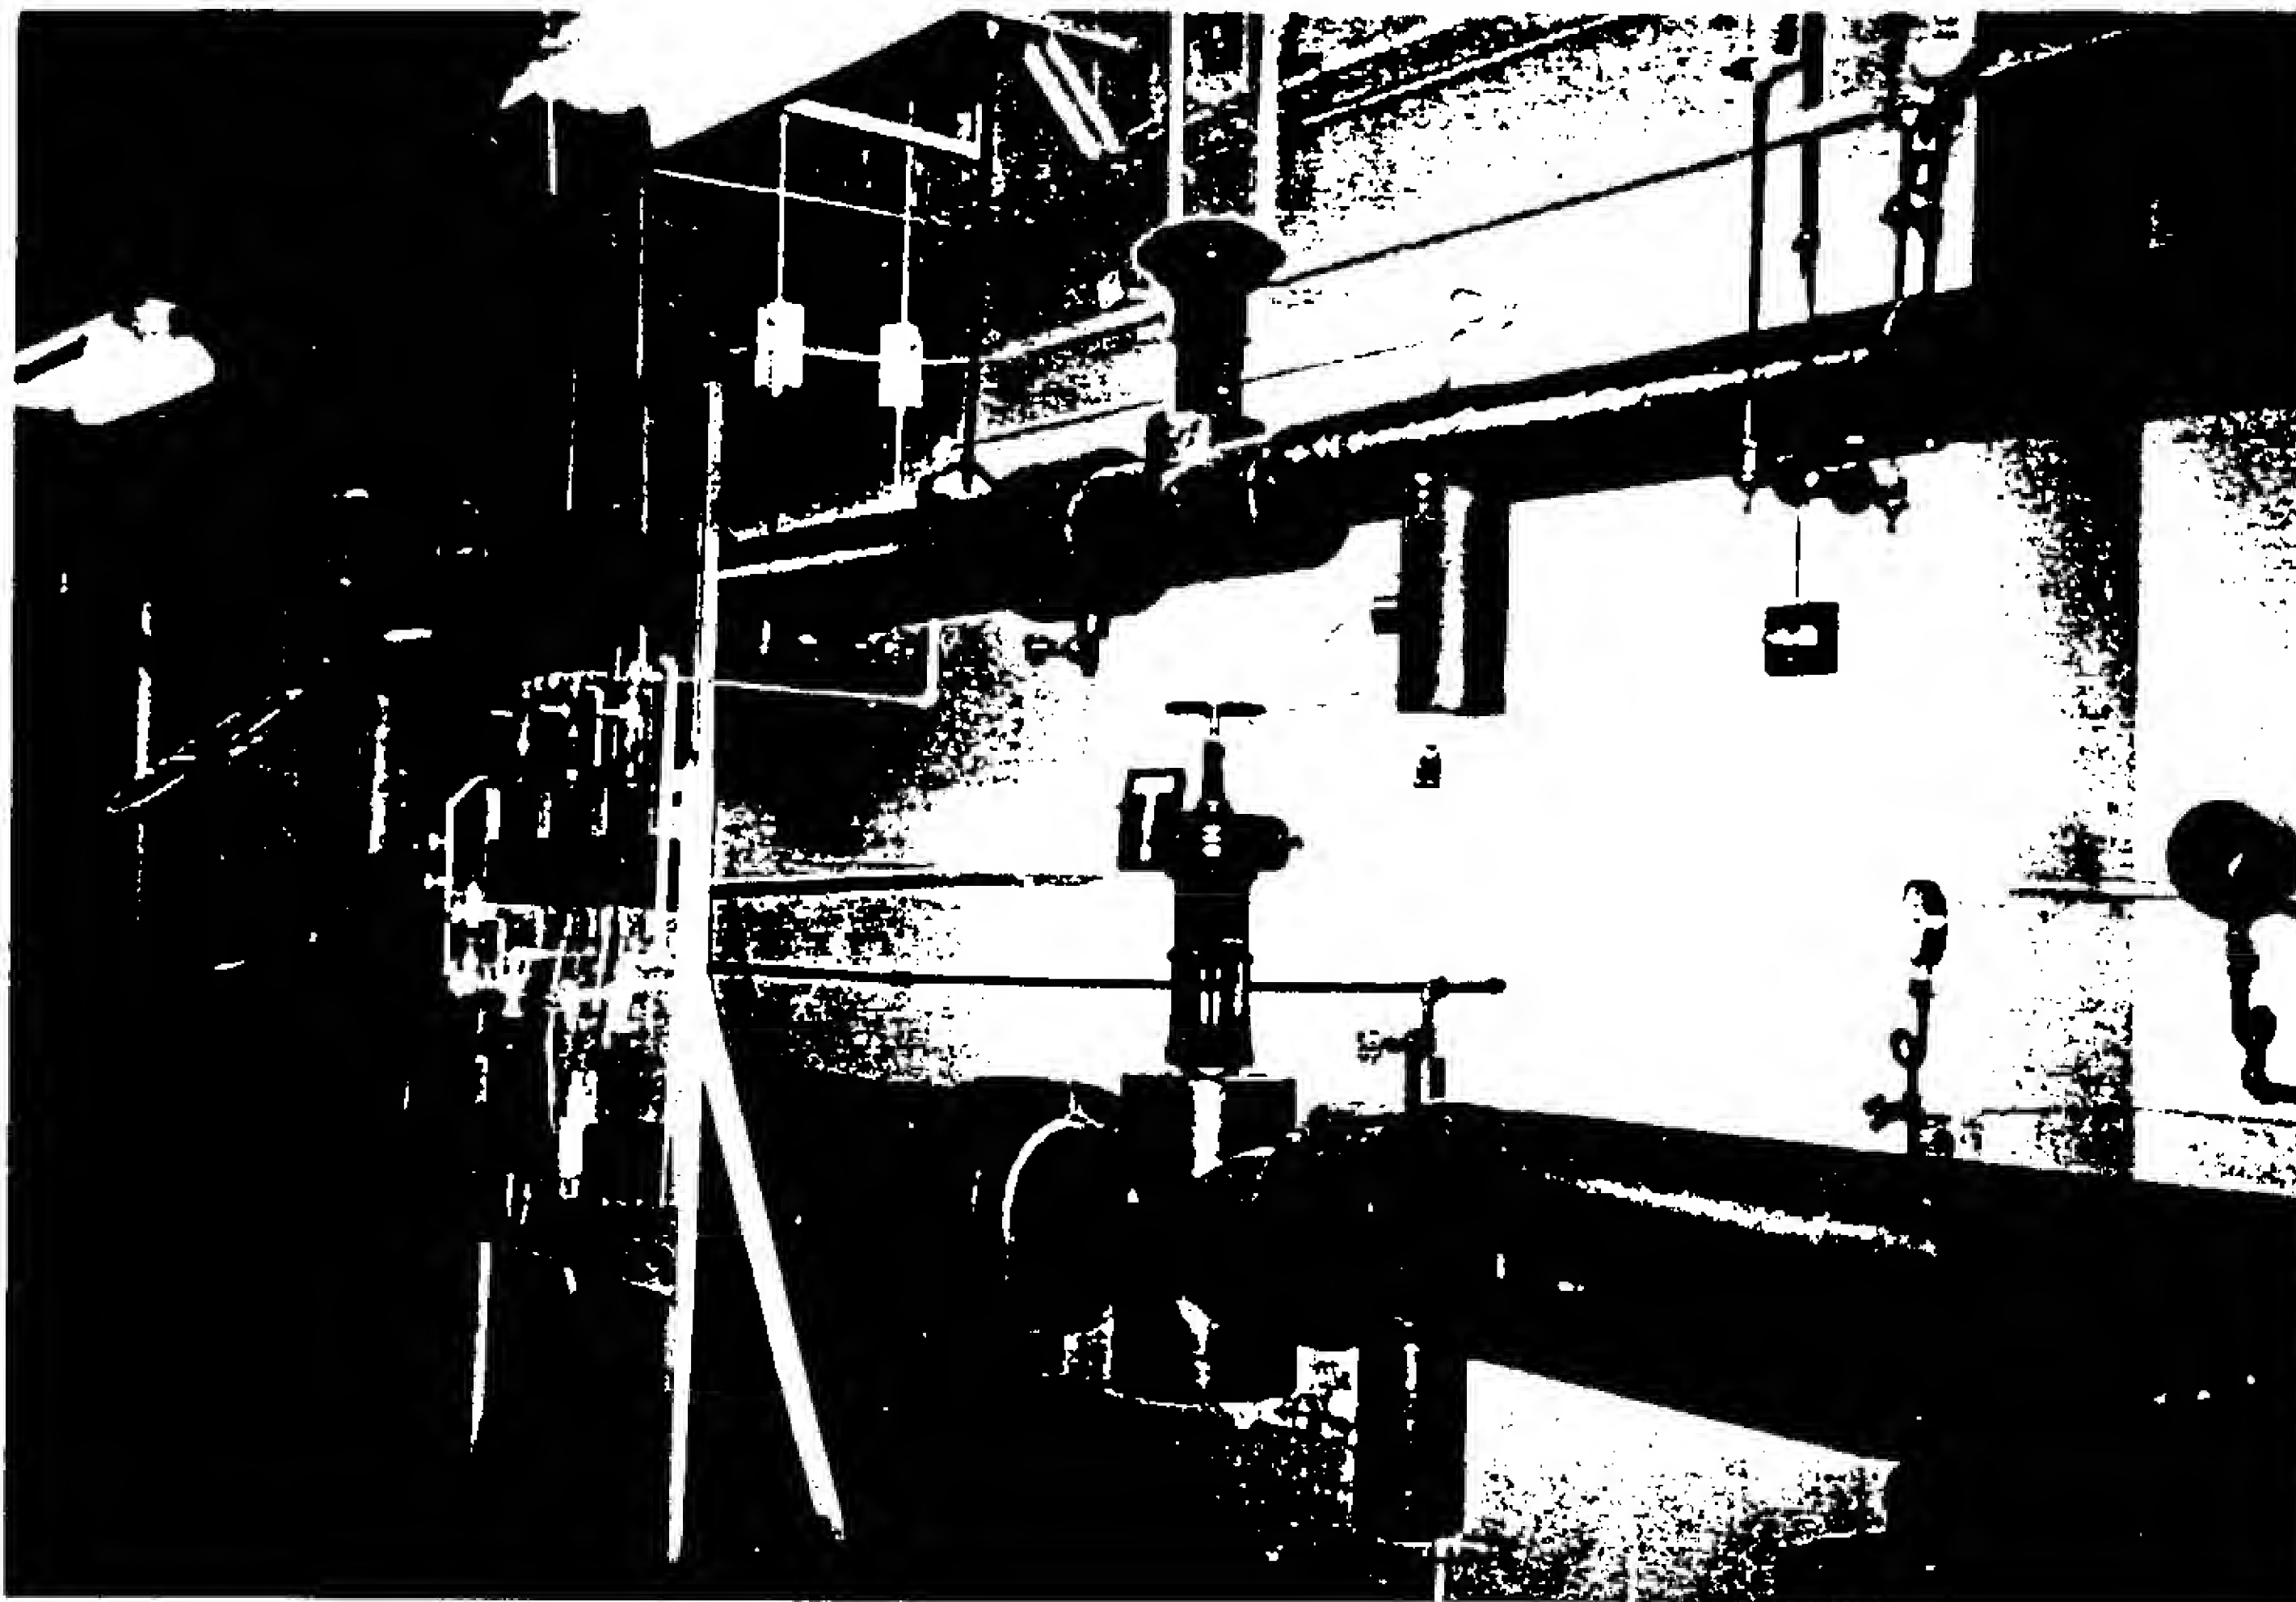
Photograph M3

**Steam pressure
reducing station**

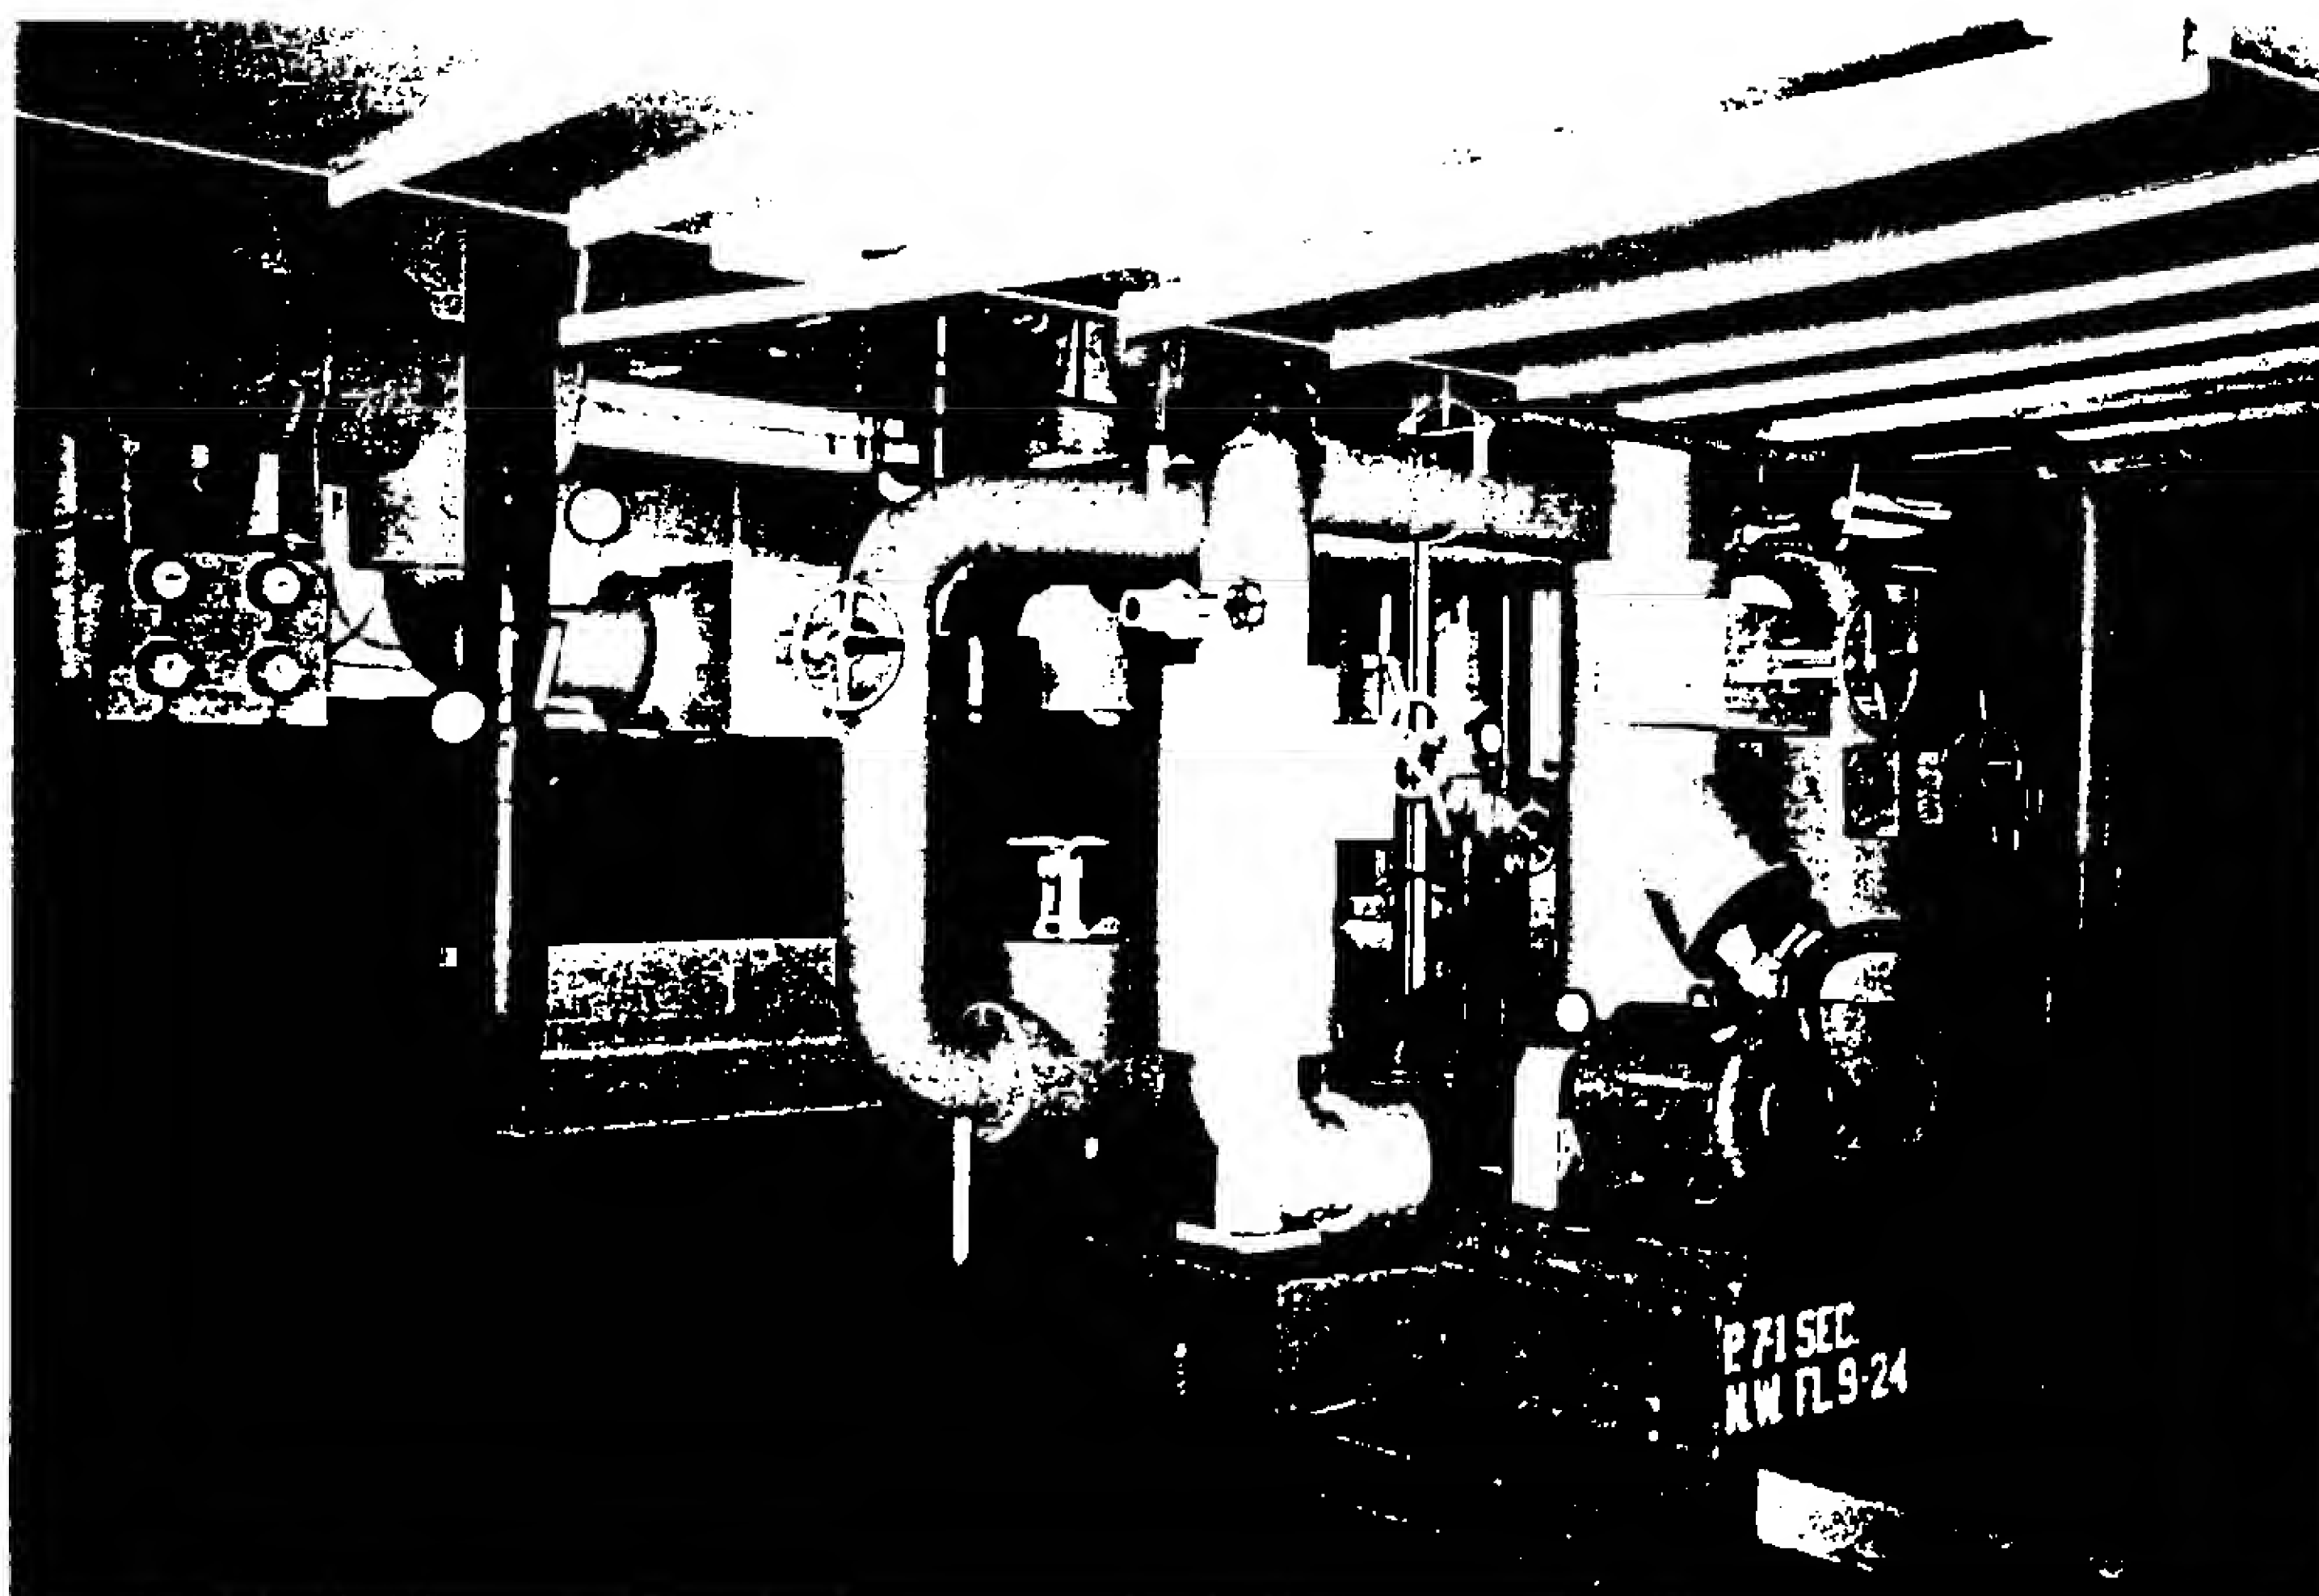
Photograph M4

**Steam and
chilled water
heat exchangers
and secondary
heating/chilled
water pumps**
